Site Survey/Walkthru

SAMPLE COMMERCIAL, 1234 Any Street, Anycity, US, 99999

Wednesday, January 20, 2016

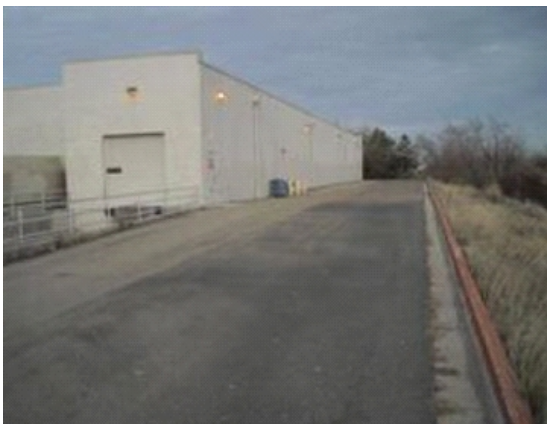
Grading / Drainage: South side of property. Adjacent property is at a higher elevation.

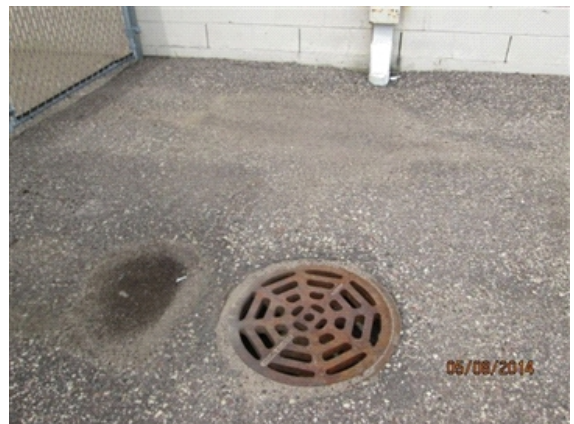
Grading / Drainage: Catch basins on the property take rainwater from the roof through downspouts and underground into the catch basins.

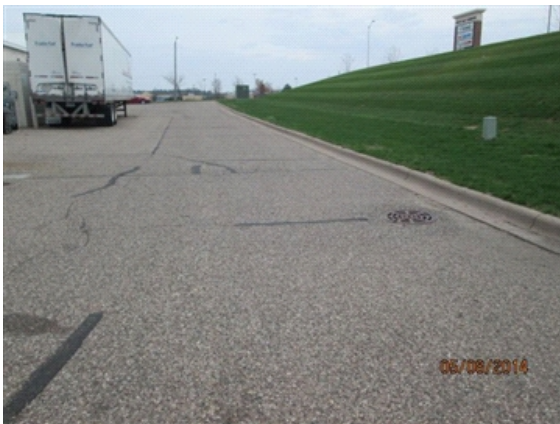
Grading / Drainage: South side of property. Adjacent property is at a higher elevation.

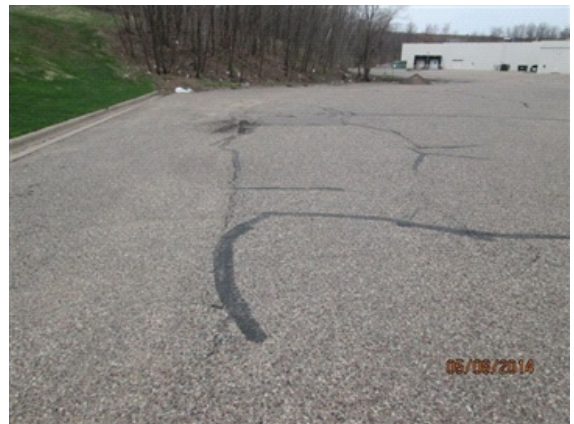
Grading / Drainage: South side of property slopes to the west to a drainage area and catch basins.

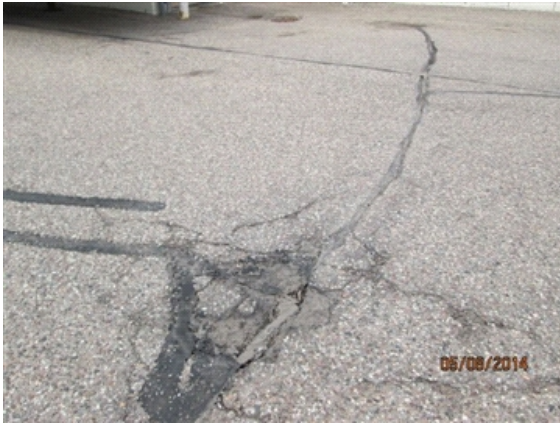
Parking lot needs to be inspected and maintained routinely as there are large cracks, (previously filled), that have reopened. Consider sealcoating of the lot after cracks have been repaired and filled.

Parking Lot: Parking lot cracks

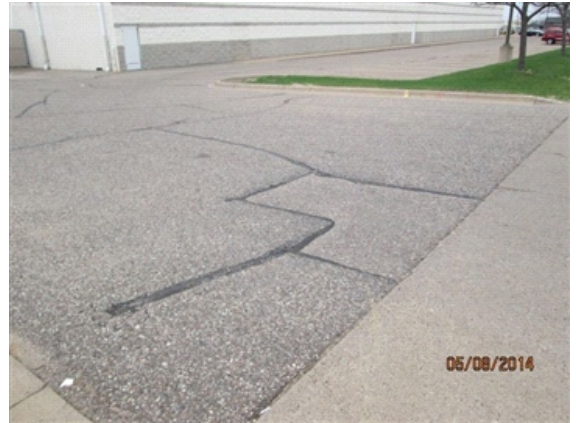
Parking Lot: Entrance to driveway area at the southeast corner.

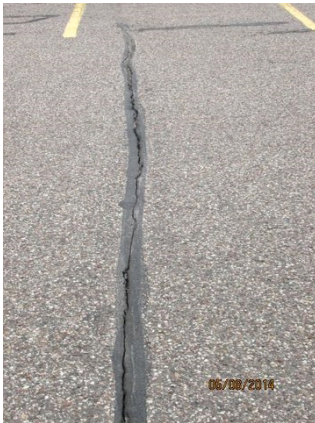
Parking Lot: Larger crack on the east side drive area.

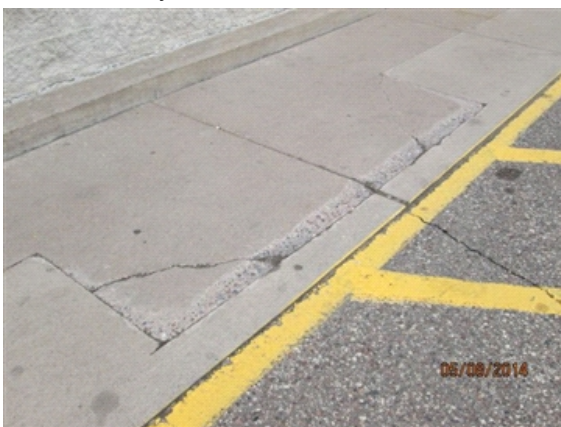
Flatworks/Sidewalks: Sidewalk area that has been ground down to eliminate a tripping hazard.

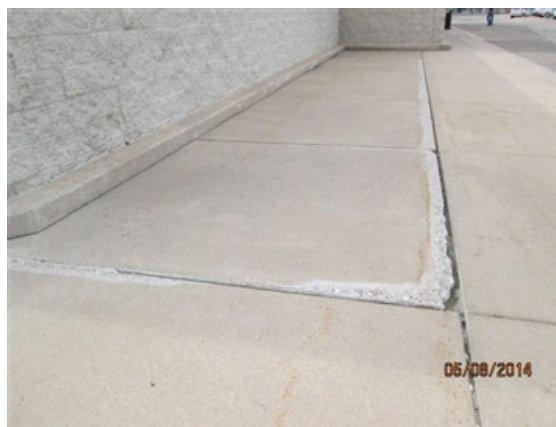
Flatworks/Sidewalks: Sidewalk at front of store showing signs of settlement. Has edges ground down.

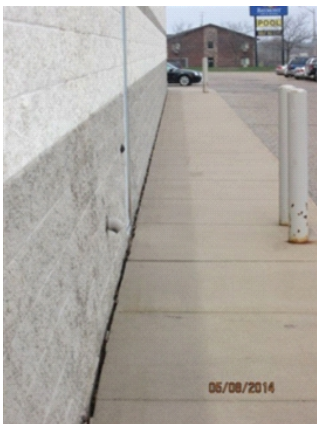
Flatworks/Sidewalks: East side of building showing opening at foundation.

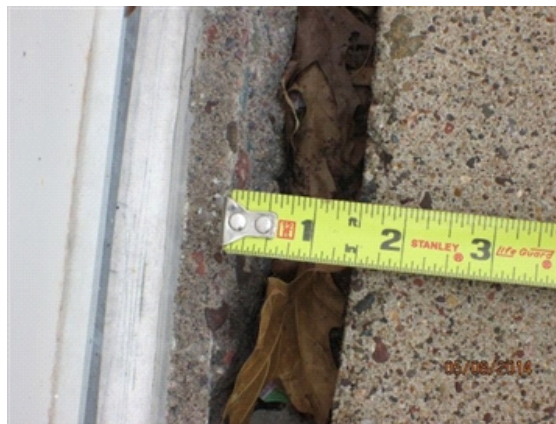
The sidewalk on the east side of the building has separated from the foundation by 1.5". There is evidence of settlement of the concrete flatwork as uplifted sections and corners have been "ground" down to eliminated tripping hazards and try to make them more level. Make repairs as needed and continue to monitor for movement.

Flatworks/Sidewalks: Sidewalk has pulled away 1.5" on the east side of the building.

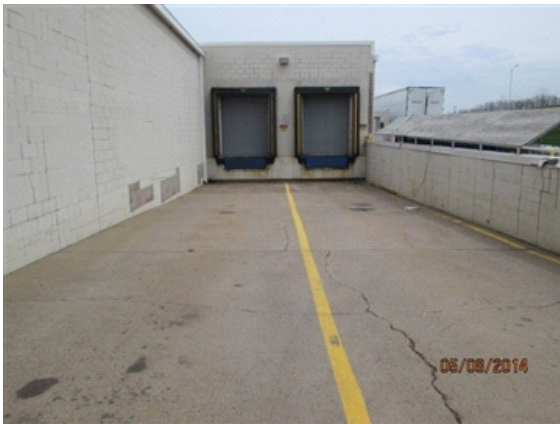
Fences / Enclosures: Truck dock area.

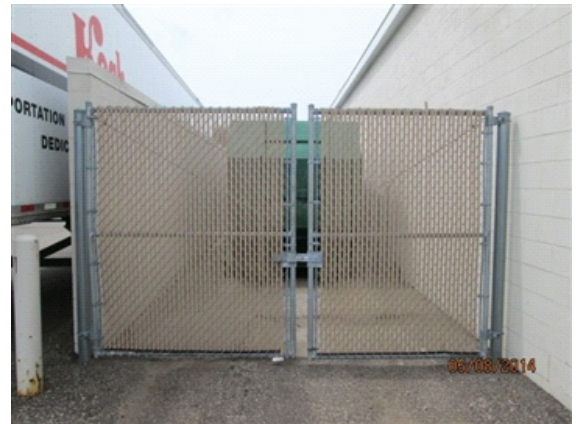
Fences / Enclosures: Fenced area for recycling compactor.

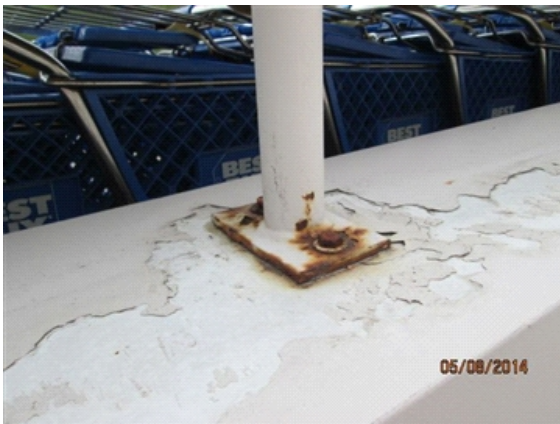
Dock area retaining wall top cap is damaged in at least three places and water can get in under the cap. The railing anchor bolts on this wall are rusting and are at risk of failing.

Fences / Enclosures: Rusted bolted connection of railing on top of loading dock wall.

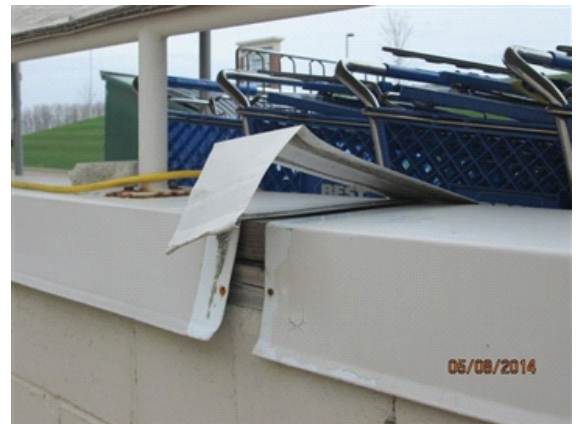
Fences / Enclosures: Top cap is damaged on the loading dock retaining wall.

Repair grass areas that have died due to "drive over" at curb as well as repair retaining wall top cap where damaged.

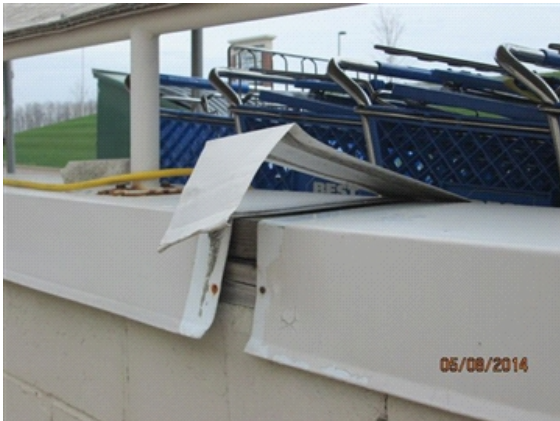
Retaining Walls/Landscaping: Top cap is damaged on the loading dock retaining wall.

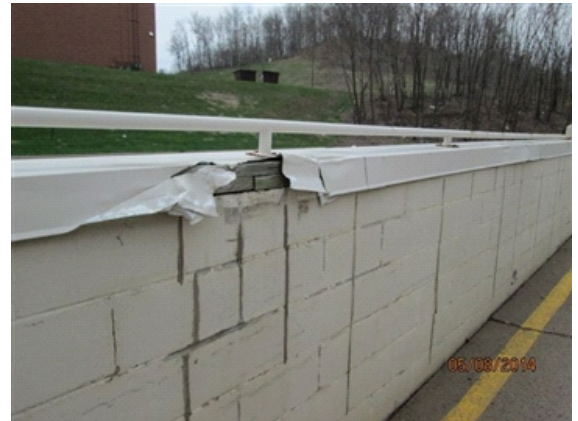
Retaining Walls/Landscaping: Retaining wall damaged top cap and block mortar joints in need of painting.

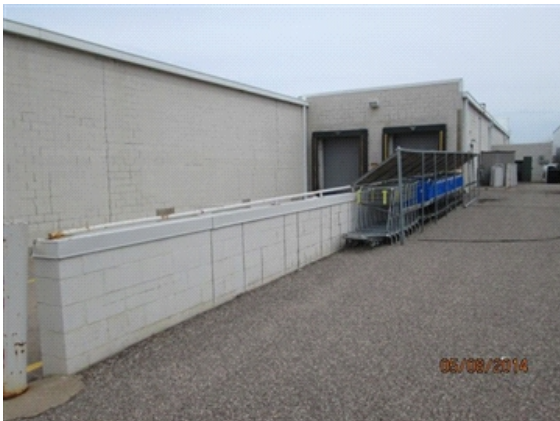
Retaining Walls/Landscaping: Dock area retaining wall.

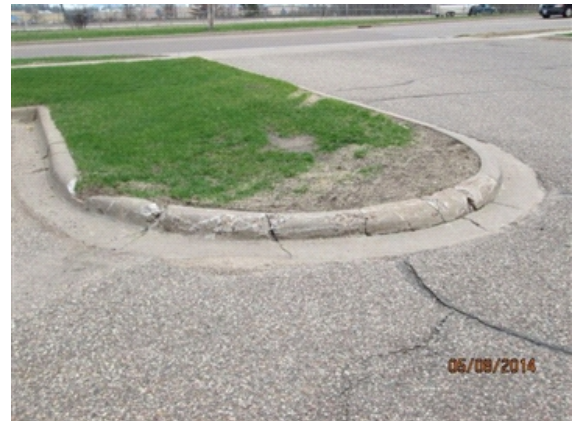
Retaining Walls/Landscaping: Curbing at southeast driveway. Note the 'drive over' area of dead grass.

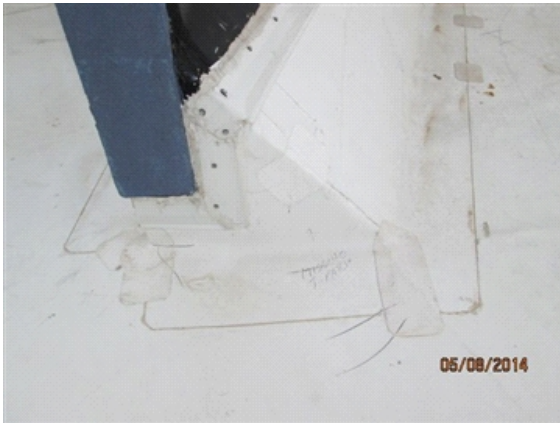
Roofing: Membrane flashing at parapet wall.

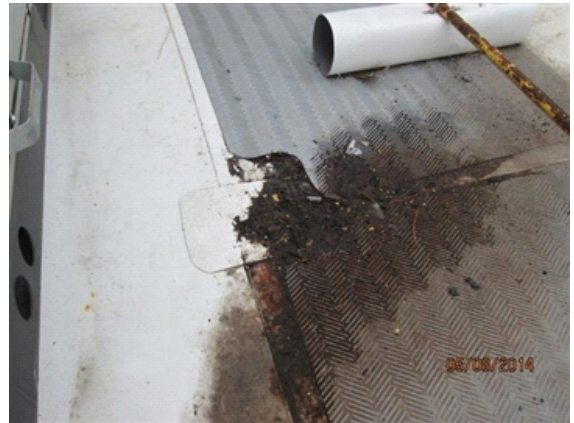
Roofing: Dirt has settled in the ponding area.

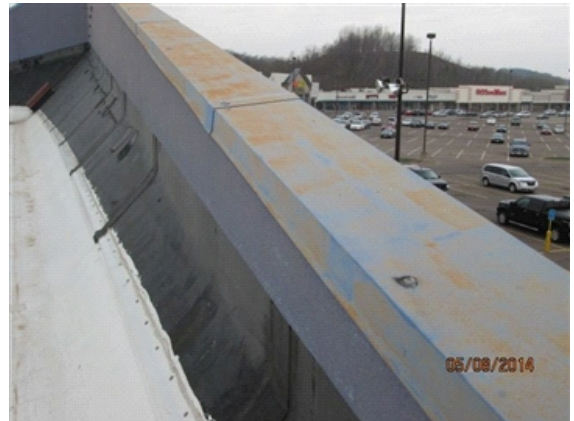
Roofing: North side galvanized top cap flashing that is showing signs of rust.

The parapet wall was in good condition with the exception of the top cap at the front of the building which is showing signs of rust.

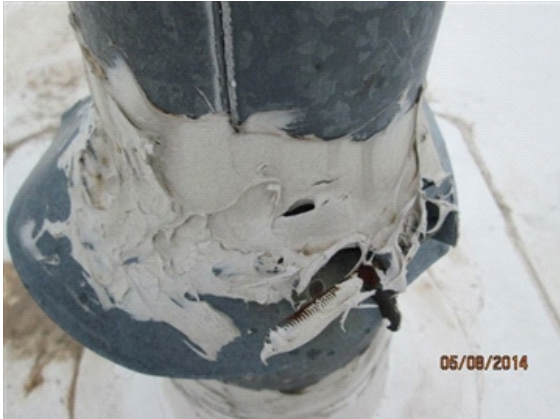
Flashing/Valleys: Open hole in caulking at vent pipe.

Repair open caulk joint on vent pipe that had been previously caulked.

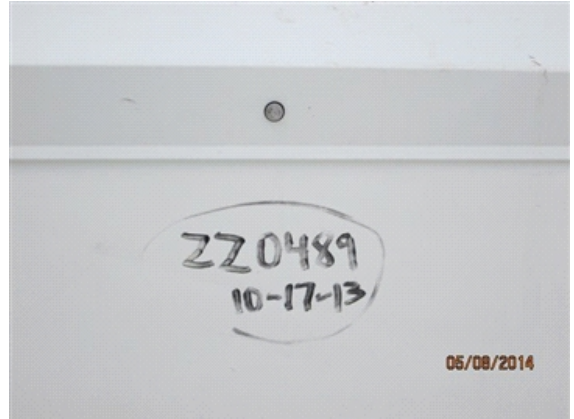
Flashing/Valleys: Roof service completion date of October 2013 and parapet wall top cap.

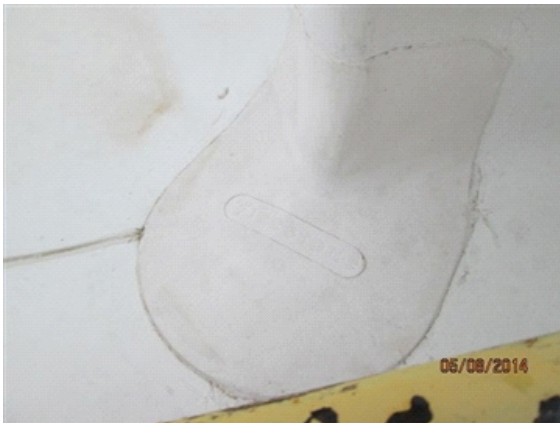
Flashing/Valleys: Membrane roof joint. Typical, in good condition.

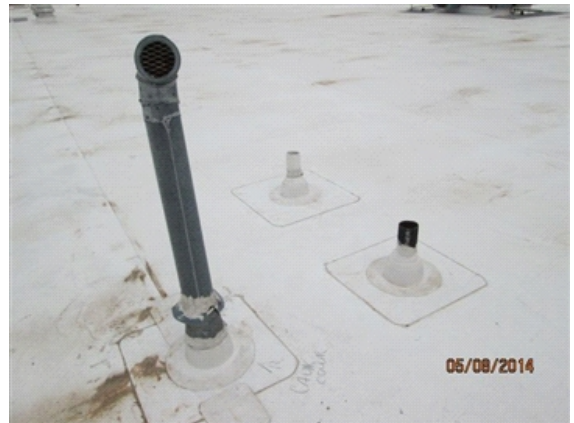
Flashing/Valleys: Typical roof penetrations.

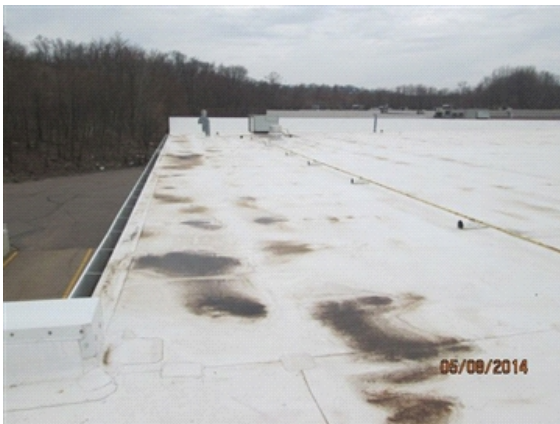
Roof Drainage System: View of the roof's south edge looking west. Gutter is to the left side.

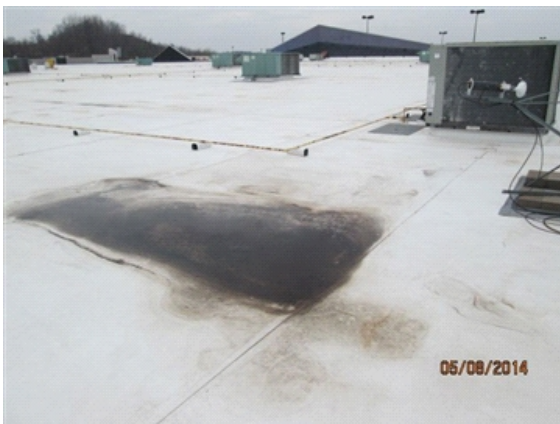
Roof Drainage System: Area of ponding on the roof.

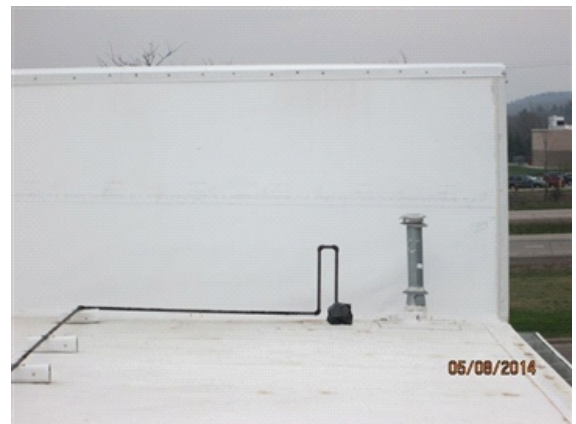
Roof Drainage System: Parapet wall looking east - gutter to the right side of photo.

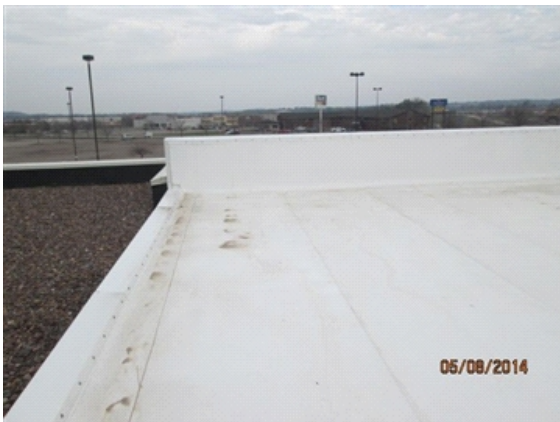
Parapet Wall: Parapet wall looking north along the west side next to adjacent roof area to another store.

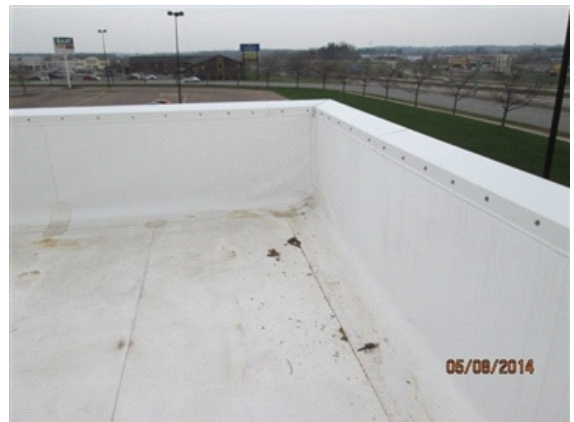
Parapet Wall: Parapet walls in northeast corner of roof.

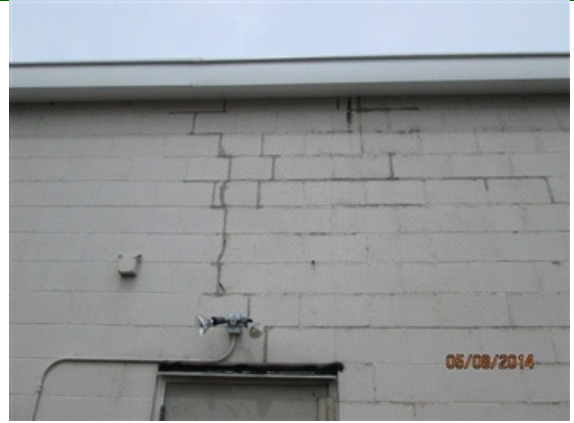
Exterior Surface: Block wall with visible joints.

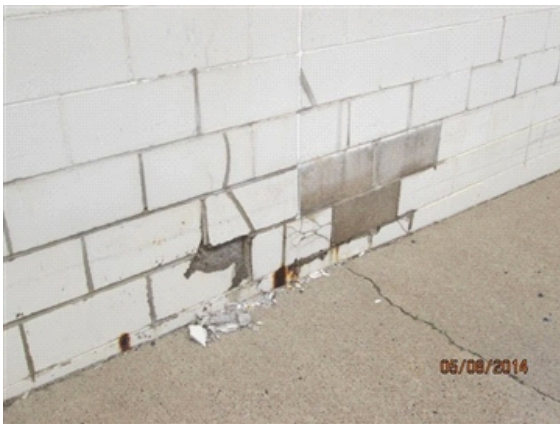
Exterior Surface: Deteriorated concrete block face.

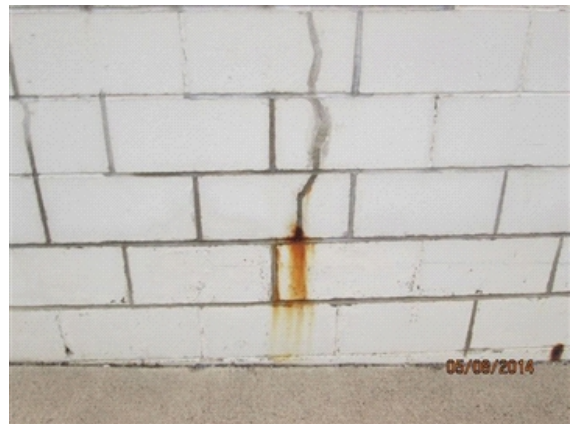
Exterior Surface: Concrete block vertical crack with rust.

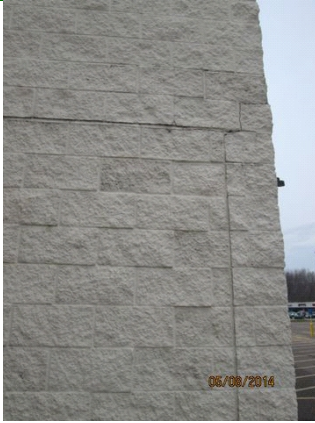
Exterior Surface: Vertical crack in concrete block at corner.

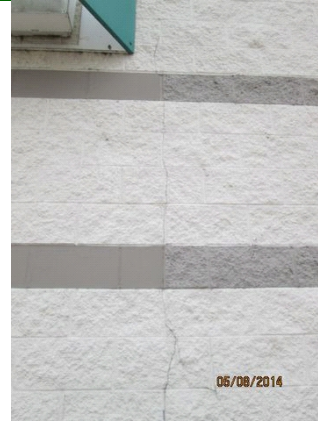
Exterior Surface: Vertical crack in wall.

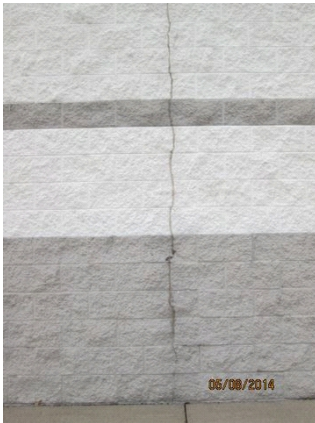
Exterior Surface: Vertical crack in wall.

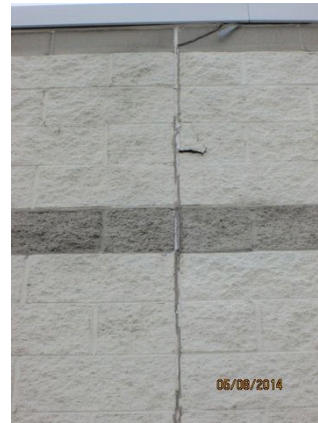
Exterior Surface: Vertical crack in wall extending all the way to the top of the parapet wall where the block has broken.

The decorative concrete block at the north and east sides of the building have some areas of cracking due to settling. Seal cracks and make repairs as necessary and monitor for any further movement. Where block mortar joints have cracked and been filled, the repairs are very visible and the wall is in need of painting.

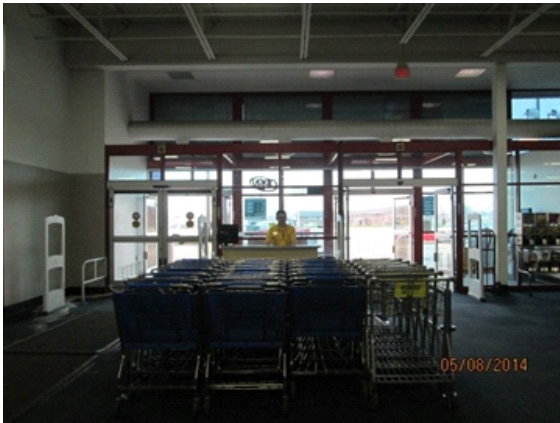
Fenestration Systems: View of windows from the inside of the building.

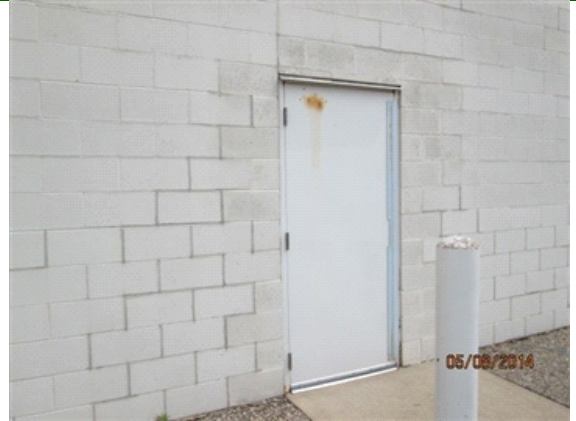
Main Doors: Exterior service door - note spot of rust at top of door.

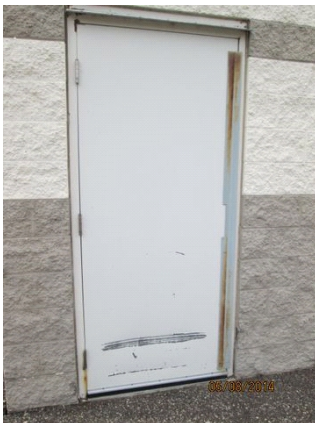
Main Doors: Service door with scratch in the bottom of door and a small spot of rust at base of frame.

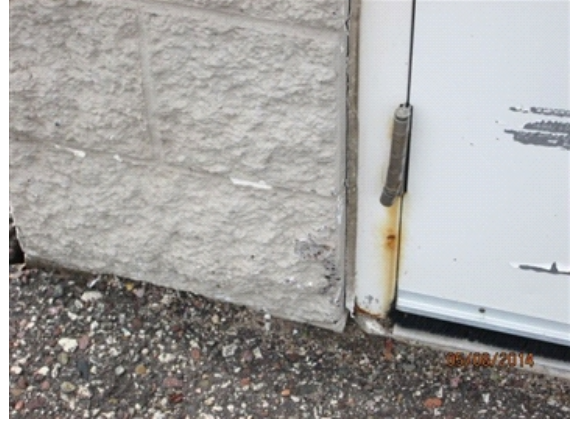
Freight Doors: Rust at bottom of service door.

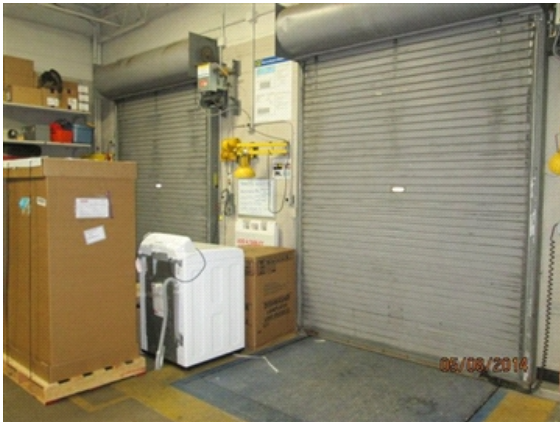
Freight Doors: Dock area freight overhead door.

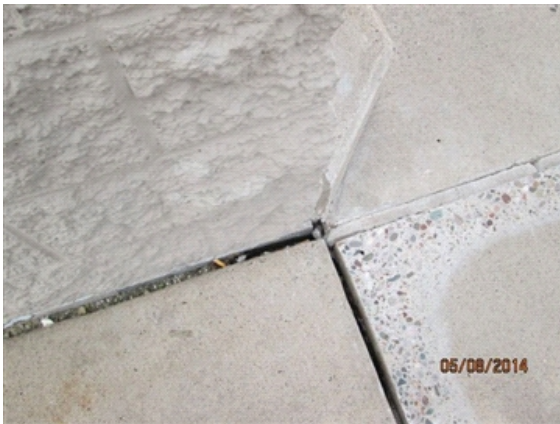
Exterior Foundation: Movement of sidewalks at foundation.

Along the base of the foundation where the sidewalk areas come into contact with the exterior walls, there is the need to reseal these joints. They have been filled in the past but have opened up again.

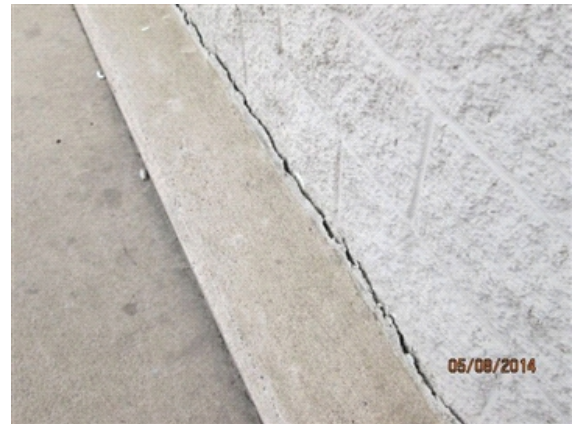
Exterior Foundation: Open joint at foundation wall.

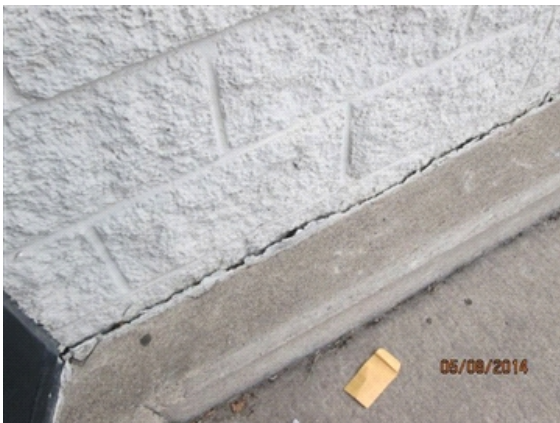
Exterior Foundation: Open joint at foundation wall.

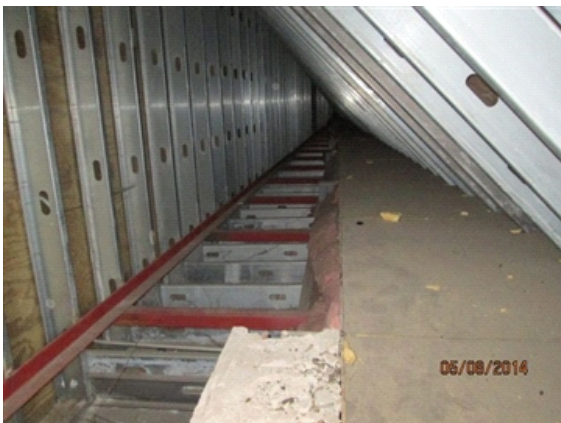
Attic Framing/Sheathing: Framing of front parapet wall - metal studs and plywood.

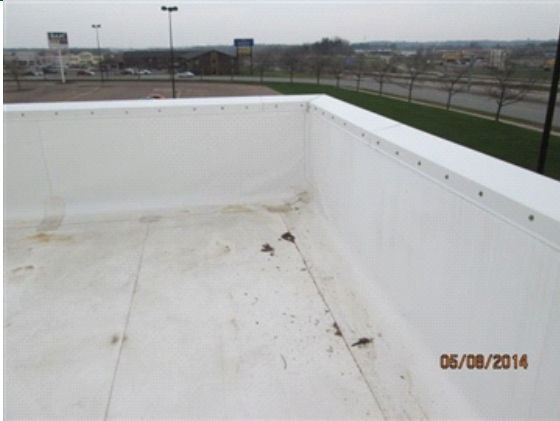
Attic Insulation: General view of roof at corner.

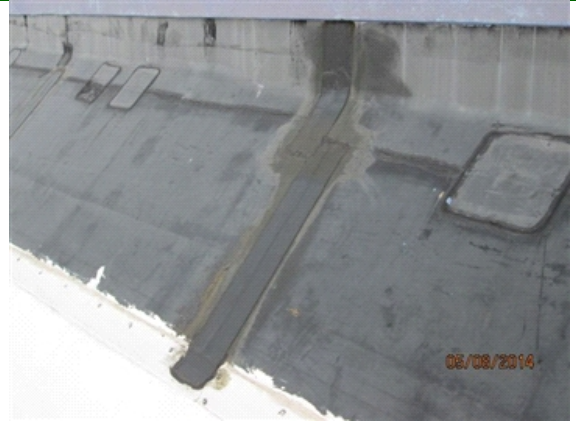
Attic Insulation: Backside of main parapet wall at north side.

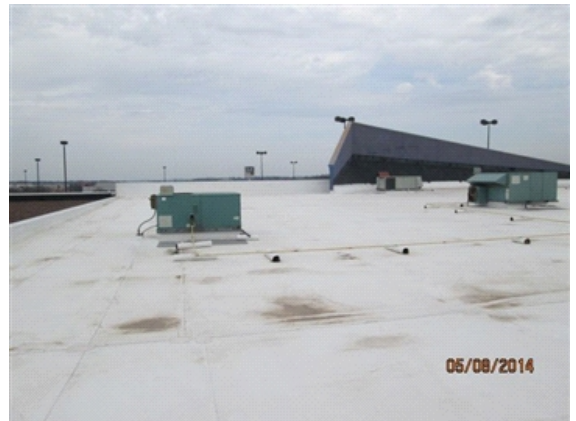
Attic Insulation: General view of roof looking north.

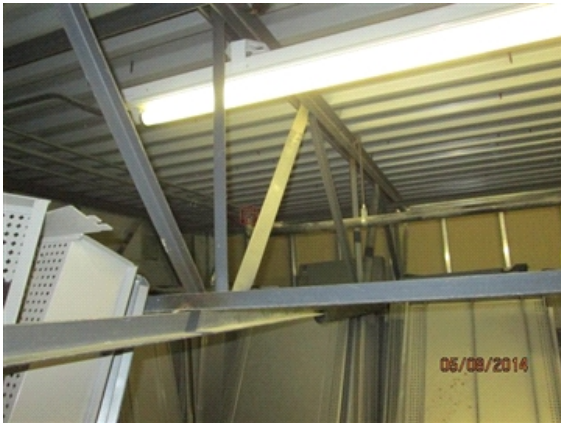
Structural Frame and Building Envelope: Detail of joist and decking.

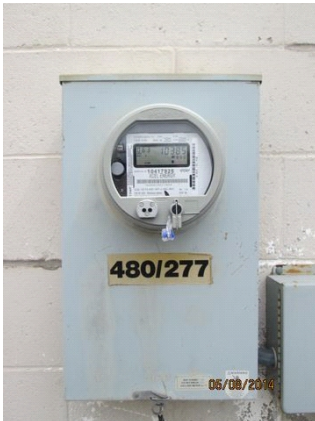
Electrical: Electric meter located on south exterior wall near transformer.

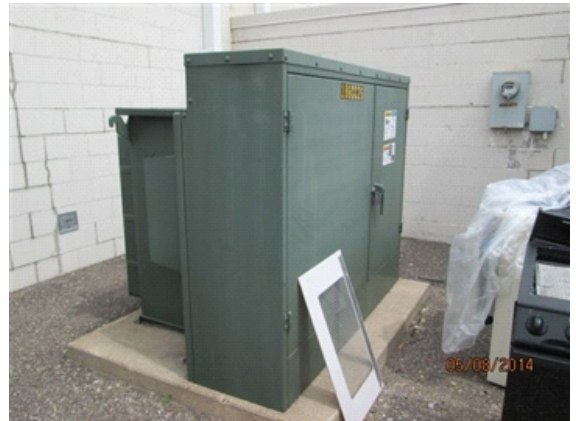
Electrical: South side transformer and meter.

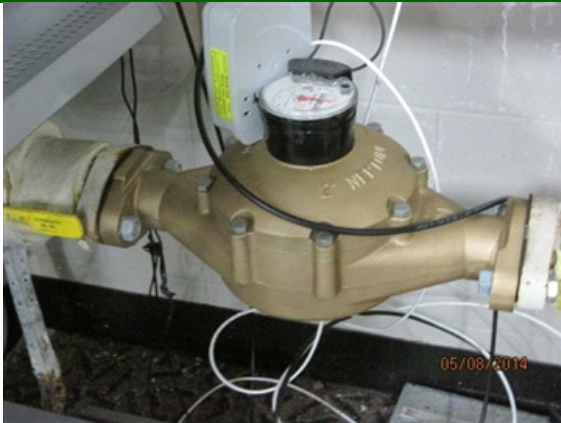
Plumbing: Water service meter located near the fire protection riser in closet off of retail floor.

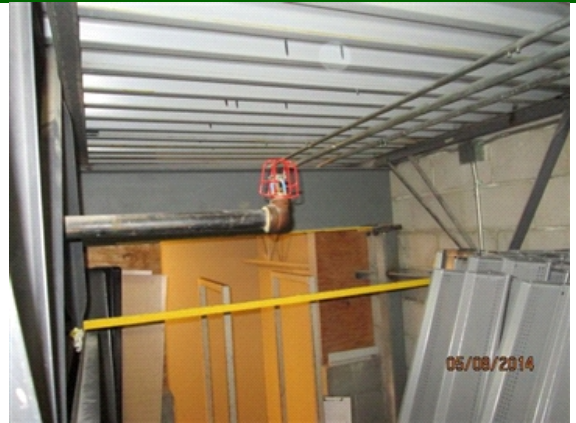
Plumbing: Fire protection system at roof metal decking.

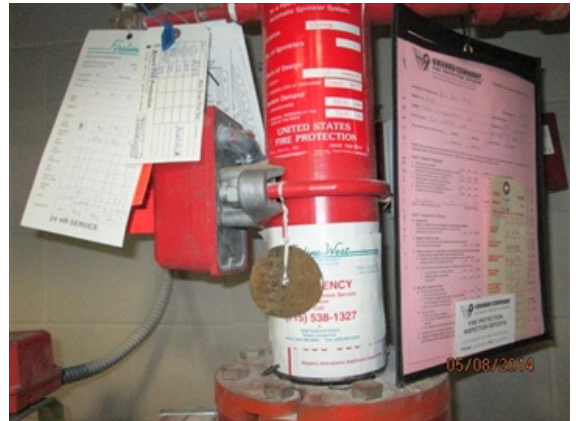
Plumbing: Fire protection service tags and records. All up to date.

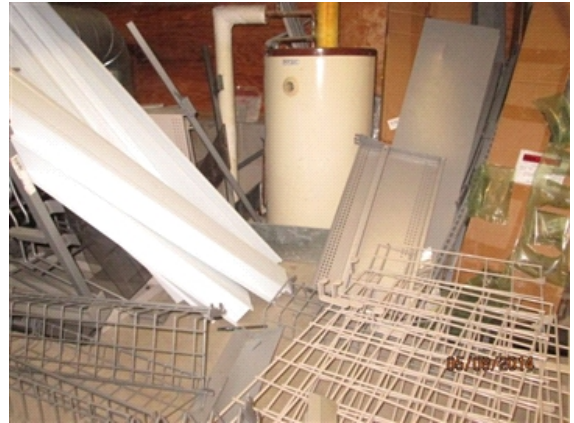
Water Heater: Access to water heater above ceiling space was blocked by stored materials.

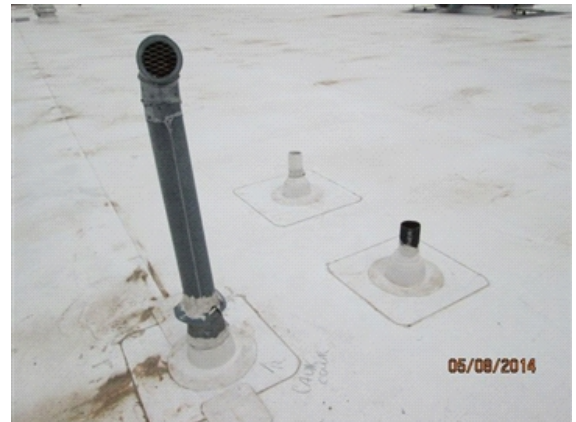
Draft Control/Vent: Typical roof penetrations.

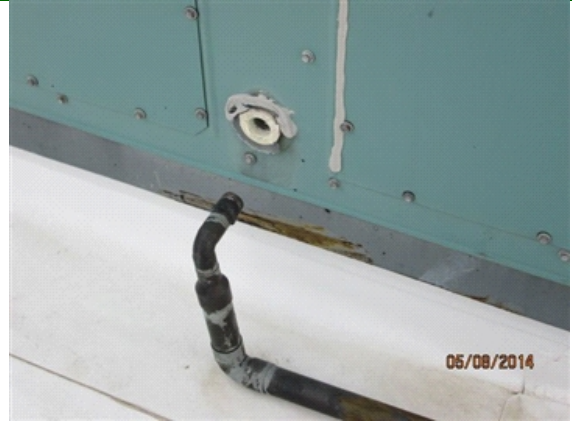
Draft Control/Vent: RTU - 7 condensate line is disconnected from unit.

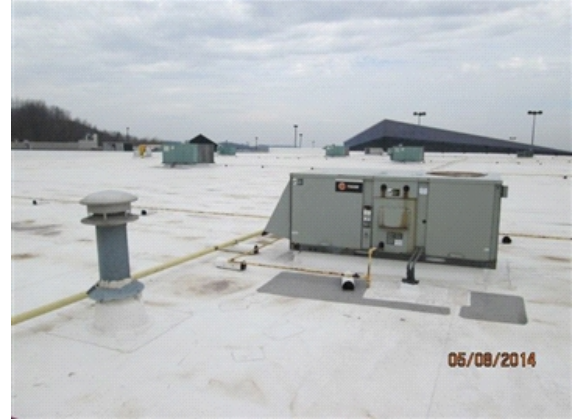
HVAC Distribution: Roof Top Unit and exhaust wiring.

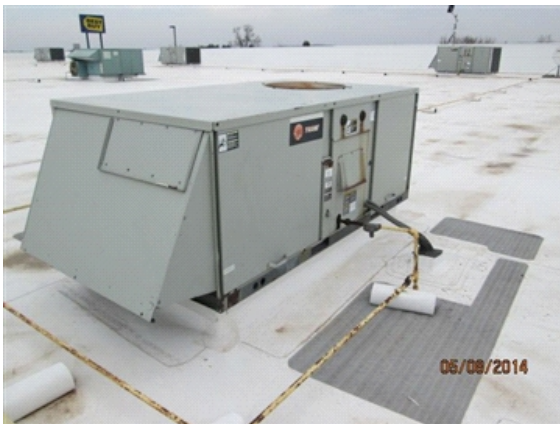
HVAC Distribution: Roof Top Unit - Typical discharge directly into the space below with minimal distribution.

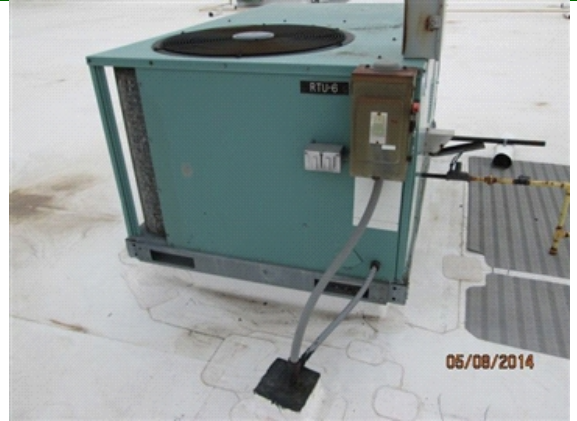
Cooling: Roof Top Unit accommodates both heating and cooling.

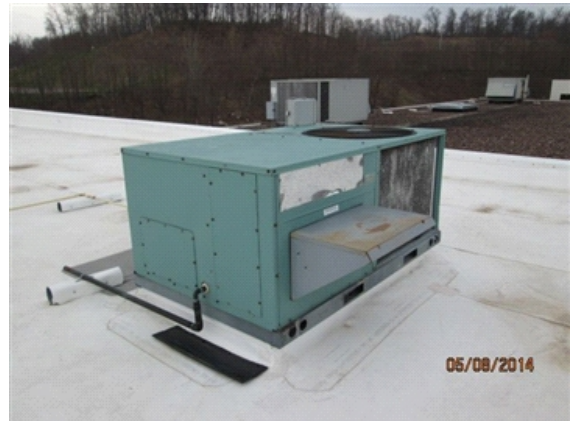
Cooling: Roof Top Unit accommodates both heating and cooling.

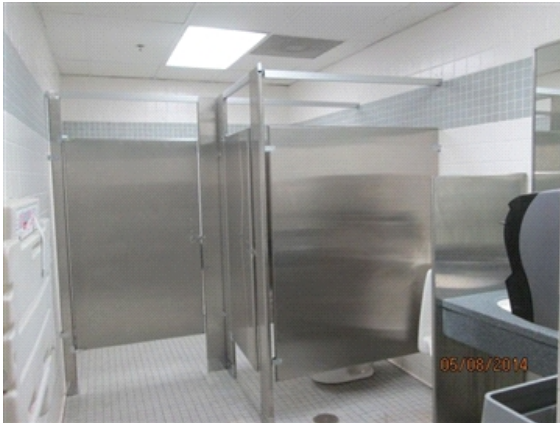
Bathrooms: Men's restroom.

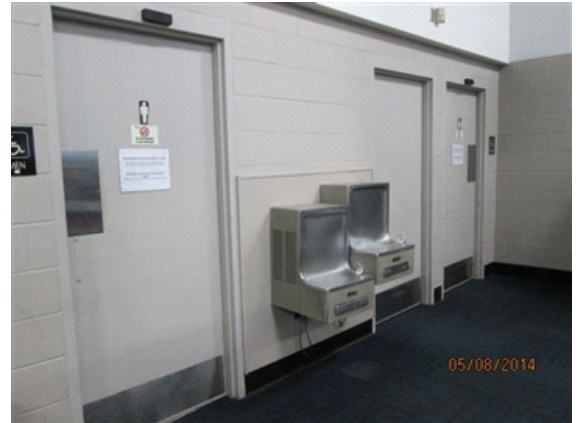
Bathrooms: View of restroom entrance doors.

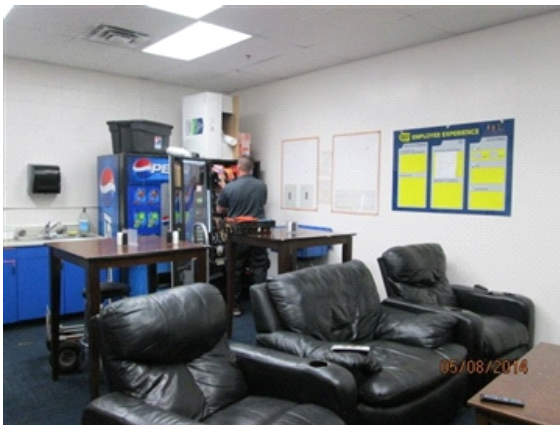
Employee Breakroom: Employee lounge and breakroom

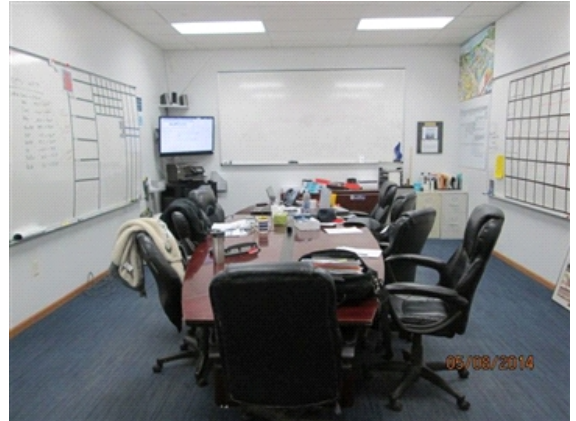
Warehouse: Warehouse meeting room.

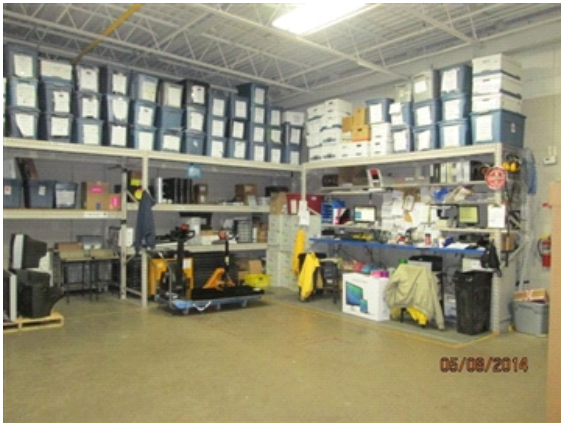
Warehouse: Shipping/receiving area next to dock doors.
