Site Survey/Walkthru

SAMPLE COMMERCIAL, 1234 Any Street, Anycity, US, 99999

Wednesday, January 20, 2016

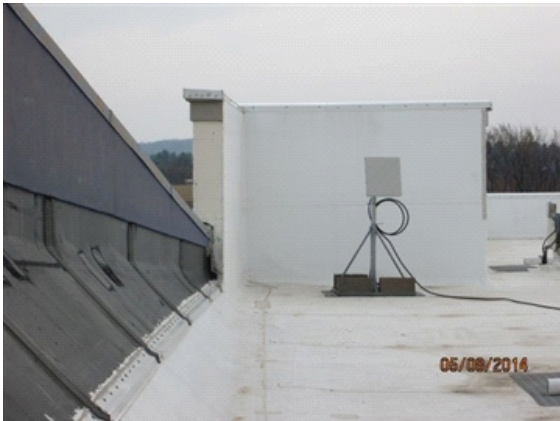
The roof was replaced last summer and a membrane roof was installed. Some small areas of ponding as evidenced by settled and dried dirt areas were seen. In a few locations where water and dirt have puddled on the roof, ensure that no seams are open to create any leaking.

Roofing: View across the north face looking east.

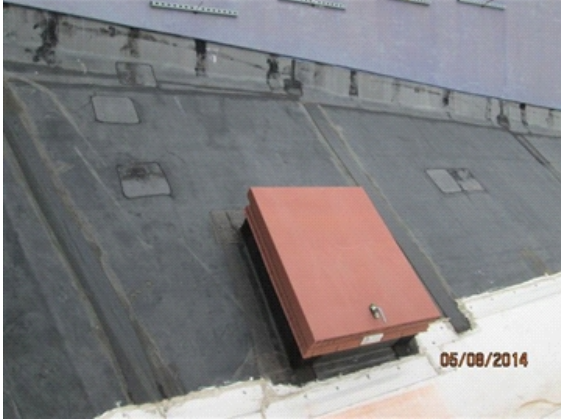
Parapet Wall: Hatchway into larger and higher parapet section.

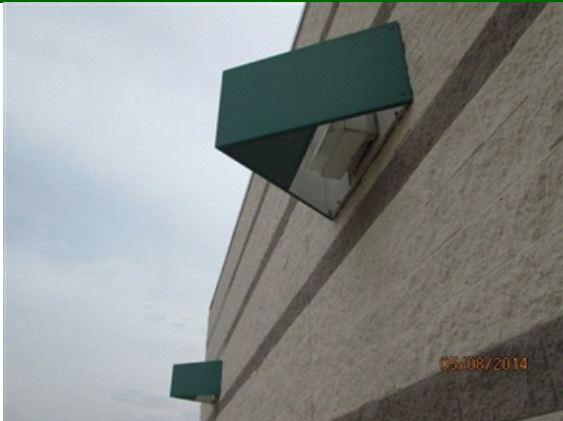
Exterior Lighting: Wall mounted lighting at the front of the building.

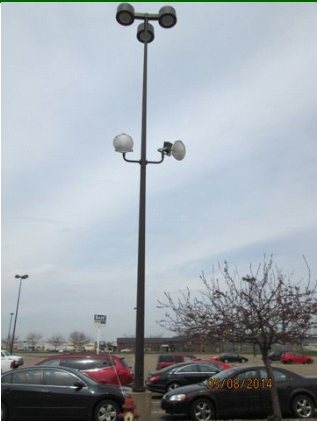
Exterior Lighting: Pole mounted lighting in the parking lot.

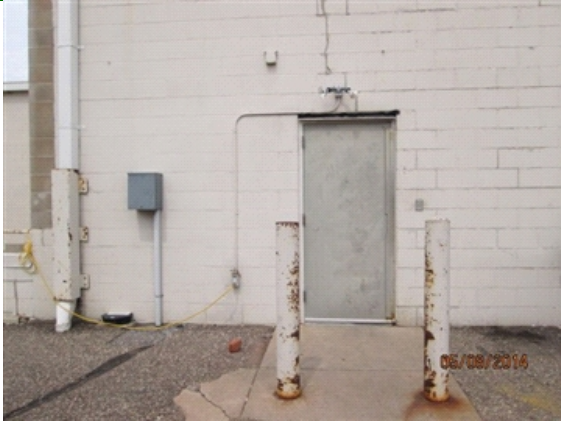
Main Doors: Main service door at shipping and receiving area.

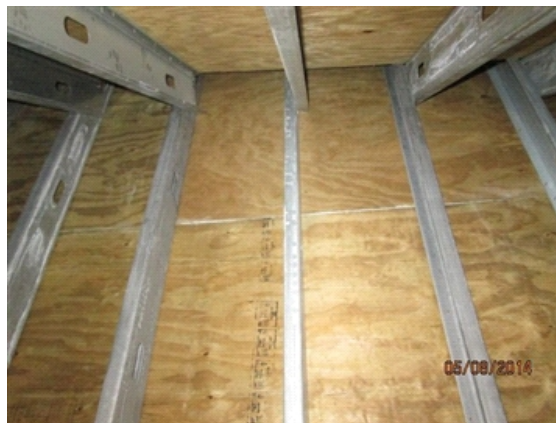
The roof structure is in good condition. The higher parapet wall is framed with metal studs and plywood.

Attic Framing/Sheathing: Framing of front parapet wall - metal studs and plywood.

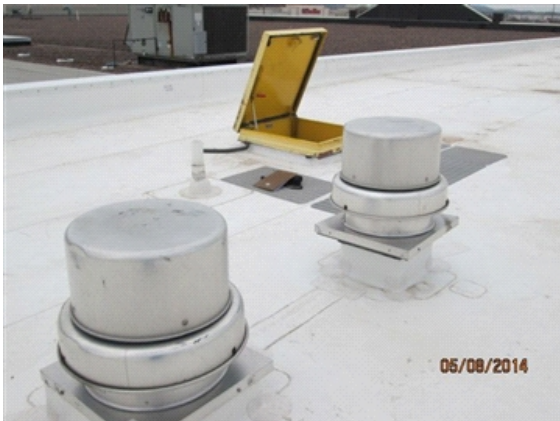
Attic Insulation: General view of roof looking south.

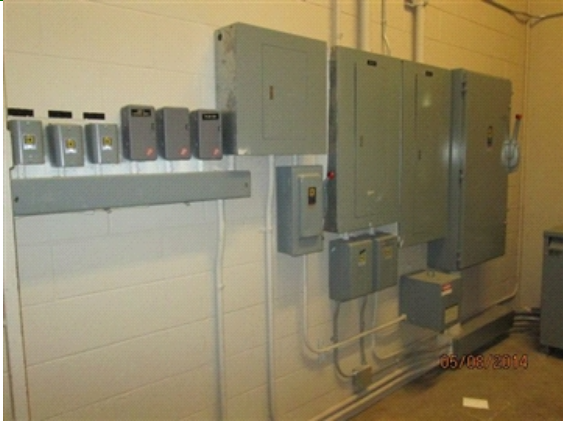
Electrical: Secondary electrical distribution room.

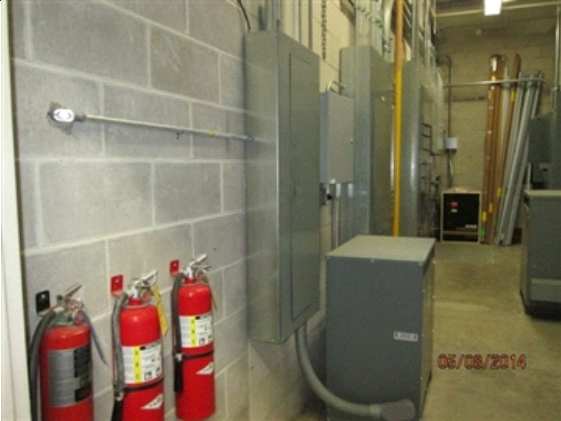
Electrical: Main electrical service room with panels and main disconnect.

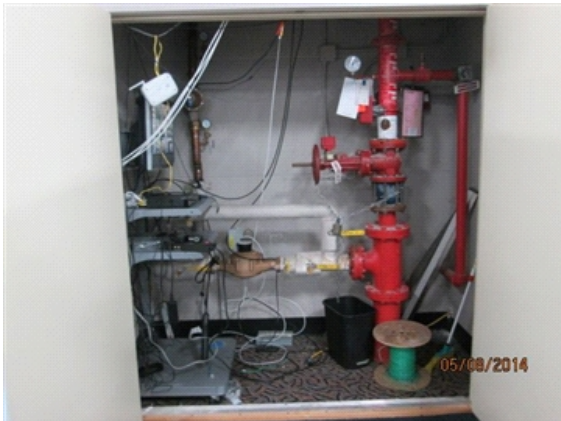
Plumbing: Fire protection and water service closet.

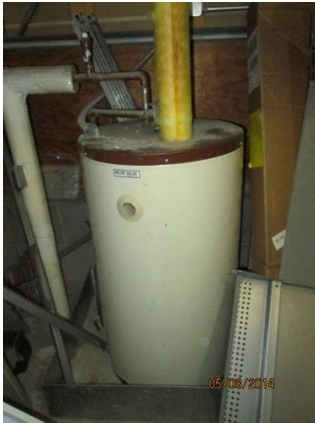
There is an approx. 20 gallon electric water heater located in the ceiling space above the restrooms. Access to the water heater was limited in the ceiling space due to stored materials in the way of reaching the unit.

Water Heater: Water heater above ceiling space.

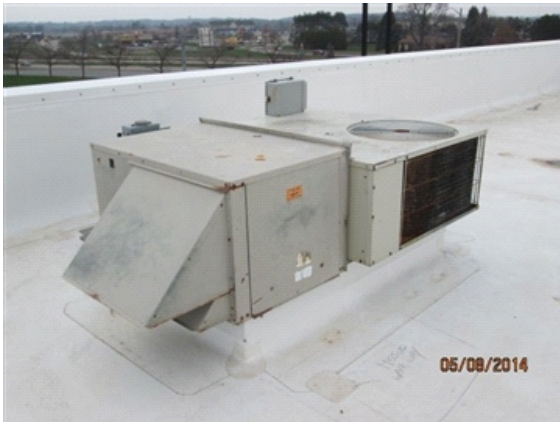
There are 6 Carrier "Weathermaker" RTU that are 20+ years old.

Heating (Carrier units): Smaller Carrier unit.

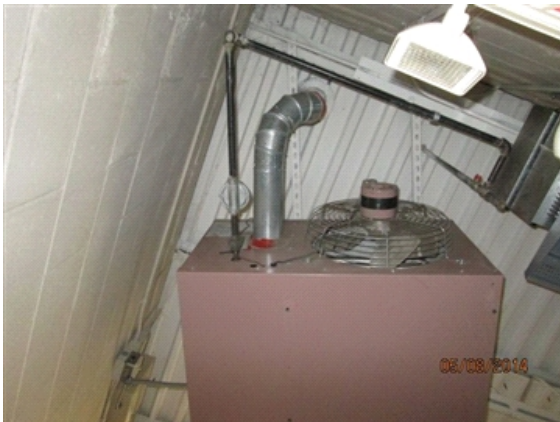
Draft Control/Vent: Gas fired unit heater ventilation through roof.

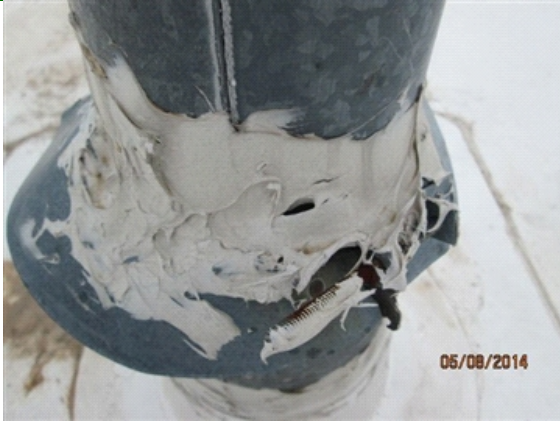
Ventilation pipe on roof has open caulk joint, (small opening) that needs to be filled to keep water out. RTU-7's condensate line is disconnected from the unit and should be reattached.

Draft Control/Vent: Open hole in caulking at vent pipe.

Repair open caulk joint on vent pipe that had been previously caulked.

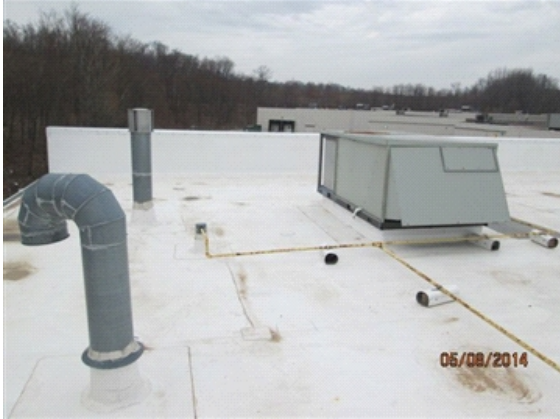
HVAC Distribution: Roof Top Unit and exhaust venting.

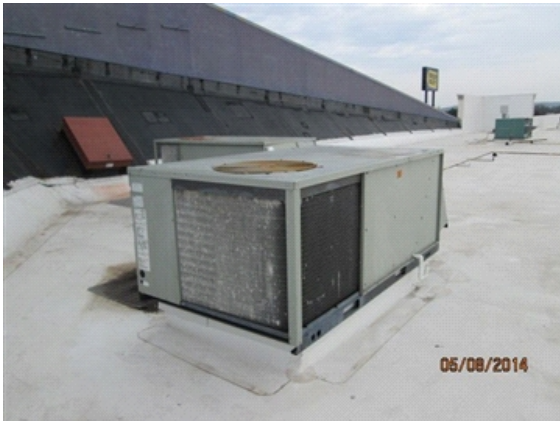
Cooling: Roof Top Unit accommodates both heating and cooling.

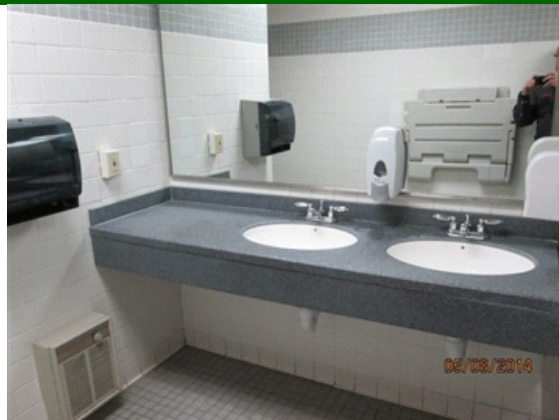
Bathrooms: Women's restroom vanity.

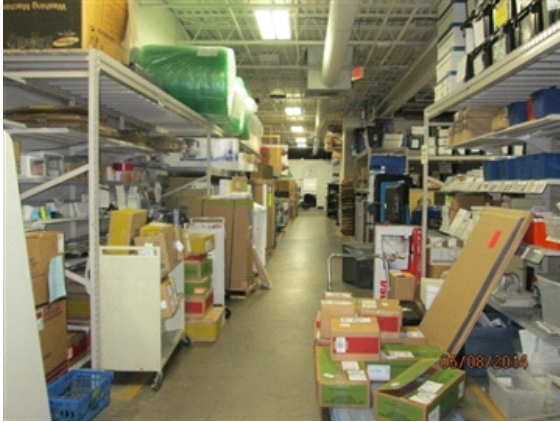
Storage: Storage area off of warehouse space.

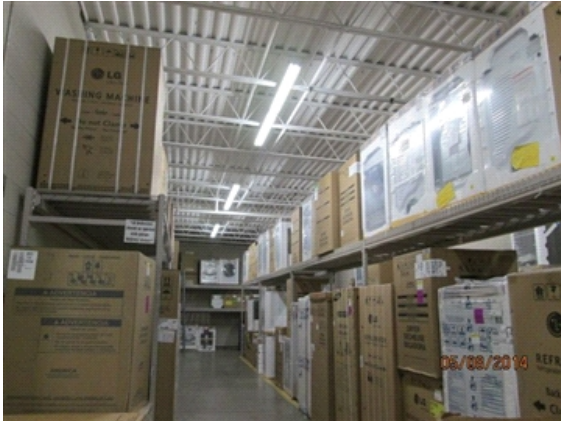
Warehouse: Warehouse rack storage.
