Site Survey/Walkthru

SAMPLE COMMERCIAL, 1234 Any Street, Anycity, US, 99999

Wednesday, January 20, 2016

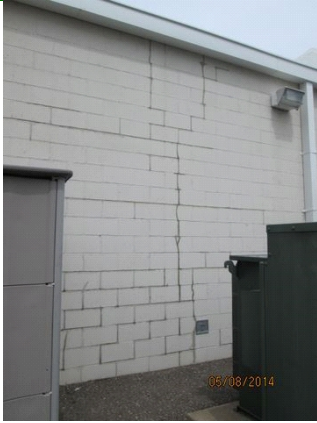
The decorative concrete block at the north and east sides of the building have some areas of cracking due to settling. Seal cracks and make repairs as necessary and monitor for any further movement. Where block mortar joints have cracked and been filled, the repairs are very visible and the wall is in need of painting.

Exterior Surface: Block wall with visible joints.

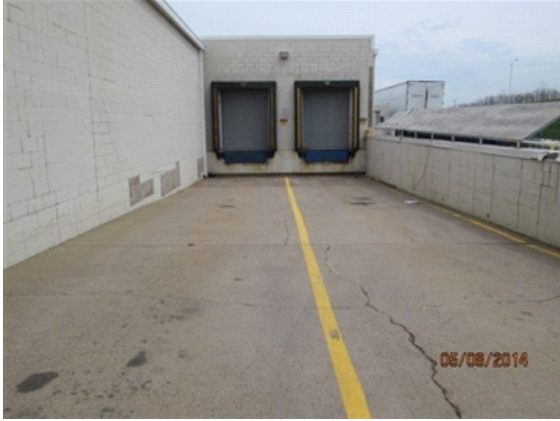
Freight Doors: Dock area - service doors.

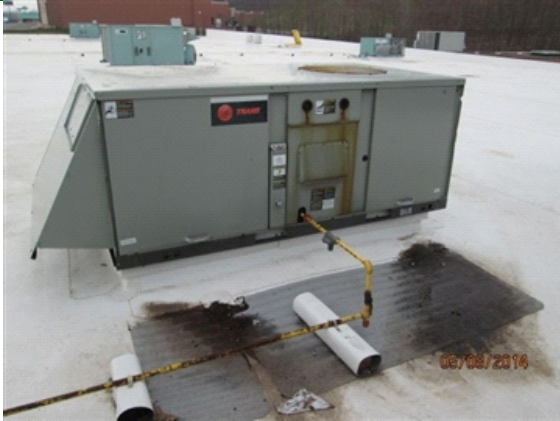
Cooling: Roof Top Unit accommodates both heating and cooling.

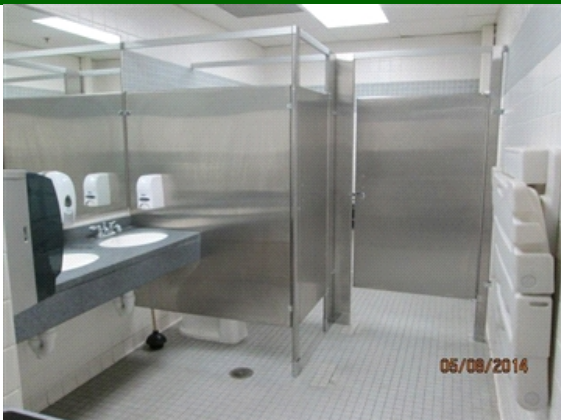
Bathrooms: Women's restroom.

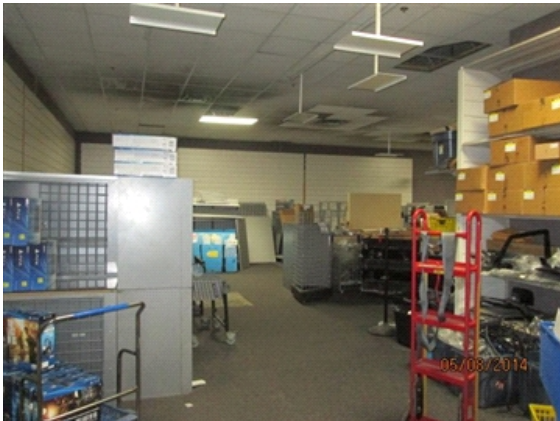
Storage: Former retail space being used for storage.
